Smoke and Dye Testing Summary

High Level Sewershed

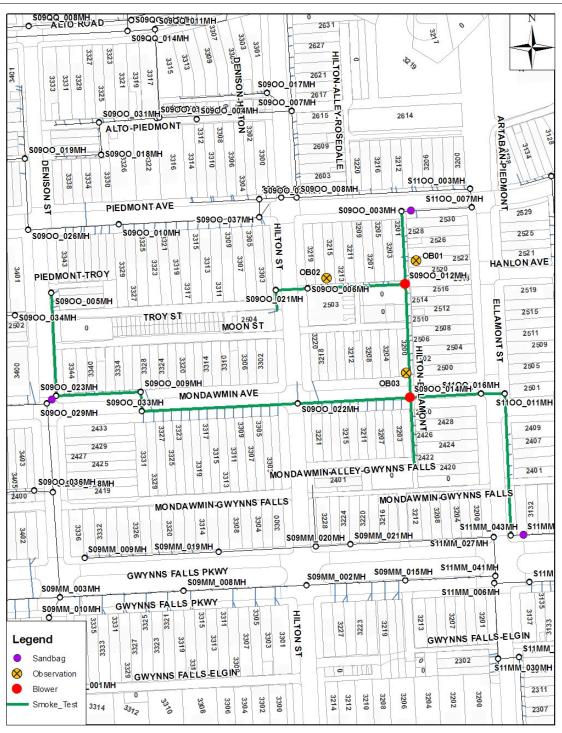
Run Summary —							
Test ID	Test Type	Date Inspected	Company / Super.	Blower MH	Ground Condition	Notification Made?	Total Length
S1028-117	Smoke	10/17/2008	ADS/TM	S09OO_014MH	Dry	Yes	2,222.86
